NASA Contractor Report 172296

**FLIGHT SERVICE EVALUATION OF
COMPOSITE COMPONENTS ON THE
BELL HELICOPTER MODEL 206L --
FIRST ANNUAL FLIGHT SERVICE REPORT**

**BELL HELICOPTER TEXTRON INC.
FORT WORTH, TEXAS**

**CONTRACT NAS1-15279
MARCH 1984**

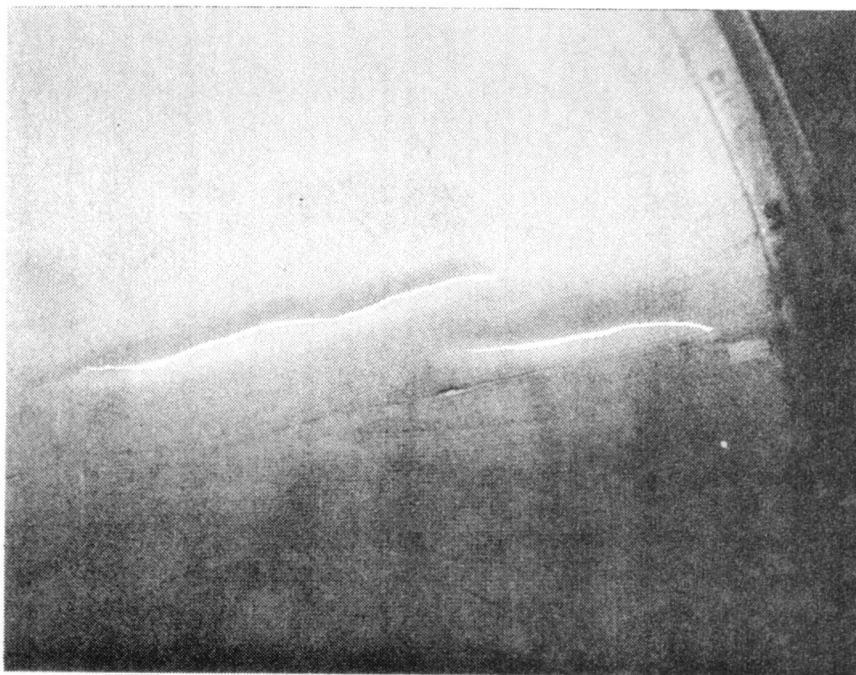
No conclusions can, as yet, be drawn from the tests of the Kevlar components. The three forward fairings failed below the average of the preservice fairings, but not below the minimum value; so on that basis, it can be said that, thus far, there has been little or no loss of strength due to service. Failure of two of the fairings was by local tearing of the buildup structure at an aft latch. The third fairing, from Island Helicopters, failed in bending at the inner radius as shown in Figure 1. Both failure modes have been observed in the preservice tests.

Figure 1. Static test failure of forward fairing after a year's flight service. Failure is compression bending of inner skin.

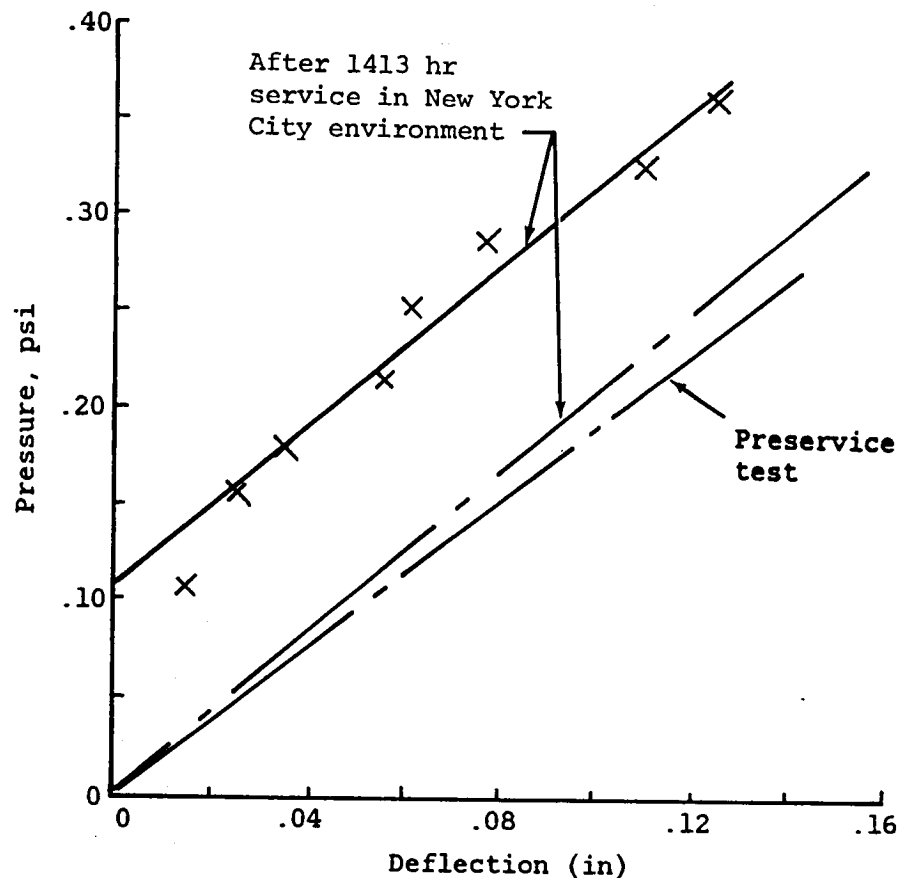
Figure 2 shows the load-deflection curve of the top centerline of the forward fairing and compares it with the load-deflection of a fairing (Reference 1) used for certification. Both sets of data were for a point located 14.5 inches forward of the aft end of the fairing. The figure shows that there was no change in stiffness after 1413 hours of service in the metropolitan New York City area.

Figure 2. Load-deflection curve of forward fairing after 1413 flight hours in New York City area.

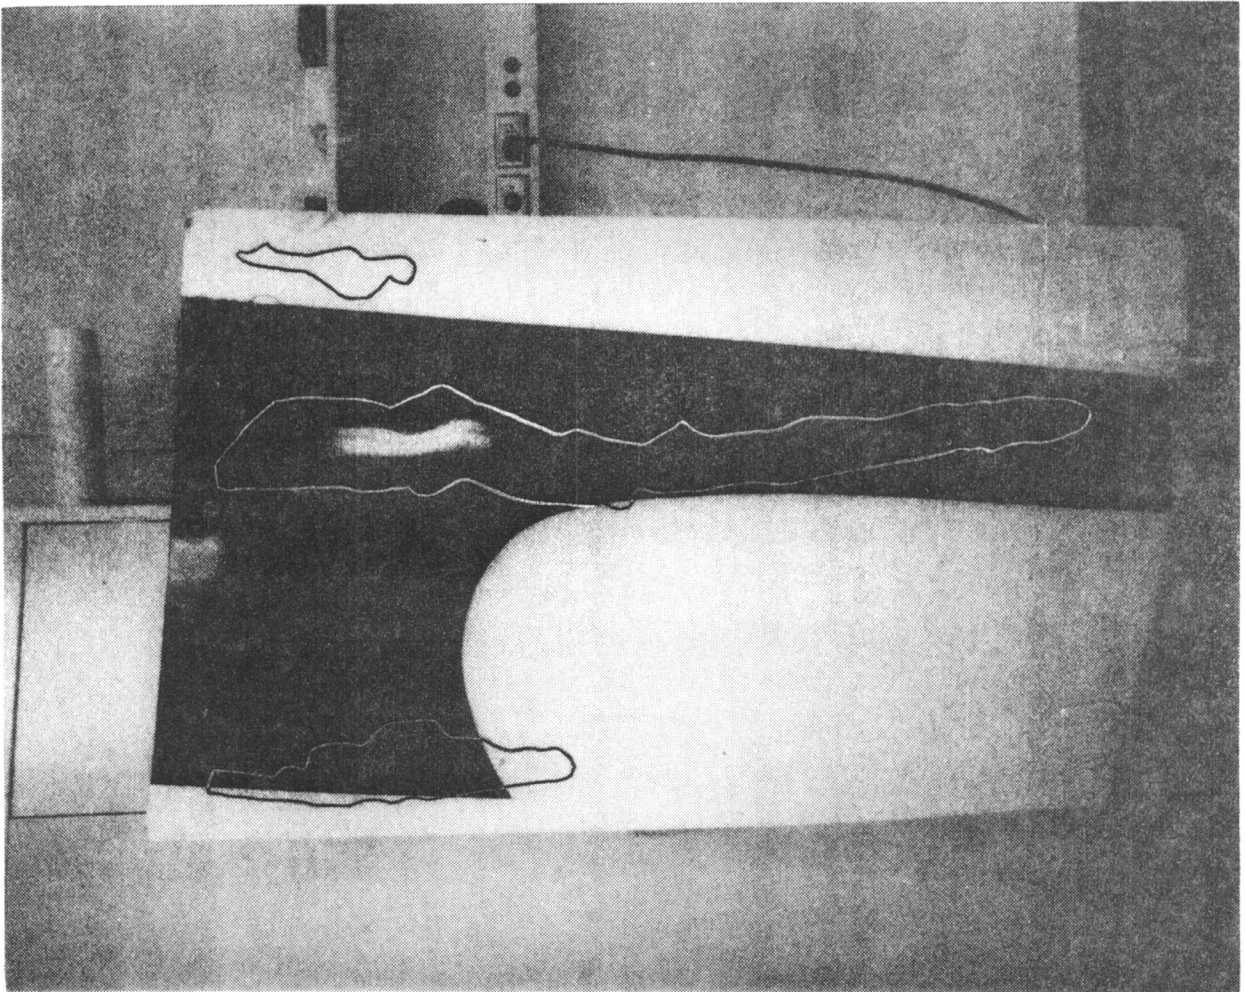
The baggage door that was returned from Island Helicopters in the New York City area failed at a low load, and the mode of failure was different from that of any previous baggage door. A loud noise was heard when the distributed load reached 275 pounds, and the door deflected noticeably. There was no observable failure after the load was removed, but the outer (tension) surface felt soft. Local tapping, followed by ultrasonic inspection revealed large areas of disbonding between the outer skin and core. Figure 3 shows the areas of disbonding.

It cannot be said, for certain, whether the low failing load on this baggage door was caused by a year's field service or by a poorly manufactured bond between the outer skin and core. It may be significant that there was no failure on the compression side. Also, in the manufacture of the baggage door, an adhesive was used between the inner skin and core, but only the matrix resin was used to bond the outer skin to the core. This is the only baggage door to fail in this manner in static test. There have been, however, occasions when the outer skins disbonded from the core in service. This is discussed in Section 4.3.

Figure 3. Static test failure of baggage door after 1413 flight hours in New York City area. Areas of disbond of outer skin-to-core is shown.

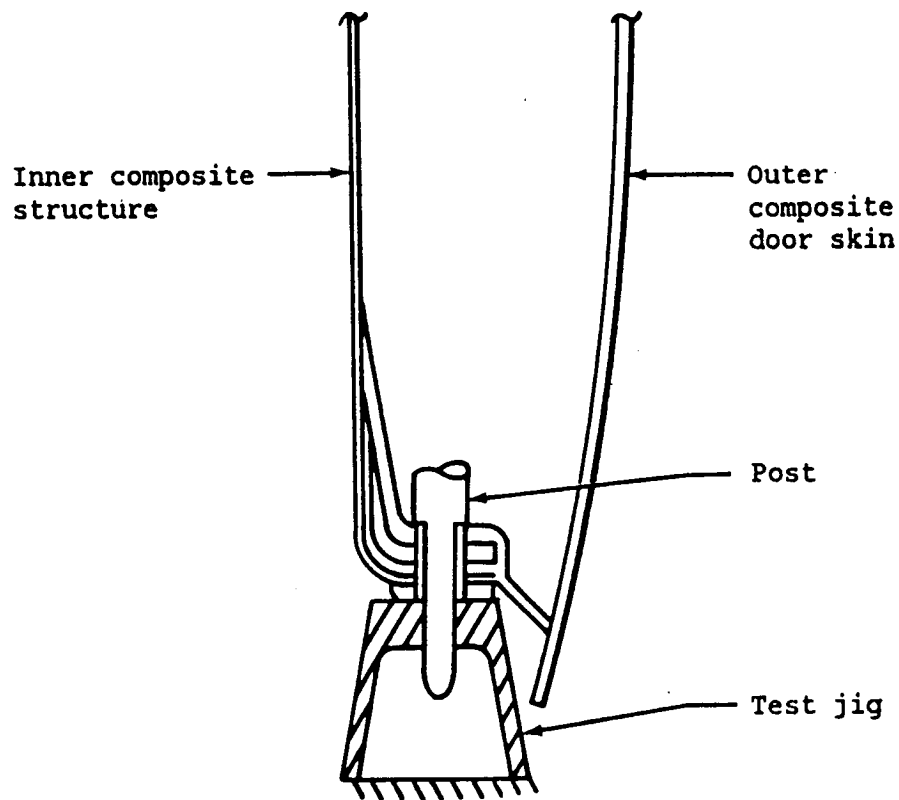
Table 3 shows an apparent loss in strength for the exposed litter doors. All three of the doors failed at a lower load than the minimum of the preservice doors; and the one located in Canada was only 6% stronger than the (average - 3 σ) preservice strength. All failures were caused by the posts pulling out of the jig. This failure mode is the same as for the preservice tests. Figure 4 shows how the post fits into the test jig that simulates the fuselage fitting.

Figure 4. Attachment of lower litter door post to static test jig.

It was thought that, although the failure mode was not a composite structural failure, it might be related to a loss in structural stiffness, which could cause excessive rotation at the end posts. Therefore, deflection data was taken during the test of the door that was returned from Island Helicopters to see if there was any loss of stiffness. Figure 5 is a comparison of deflections, at one location, between this door and the average of three doors tested before service. The figure shows a substantial loss of stiffness after 1413 hours of service. This could have caused the posts to slip out at a low load, despite the fact that the door apparently suffered no loss of structural strength.

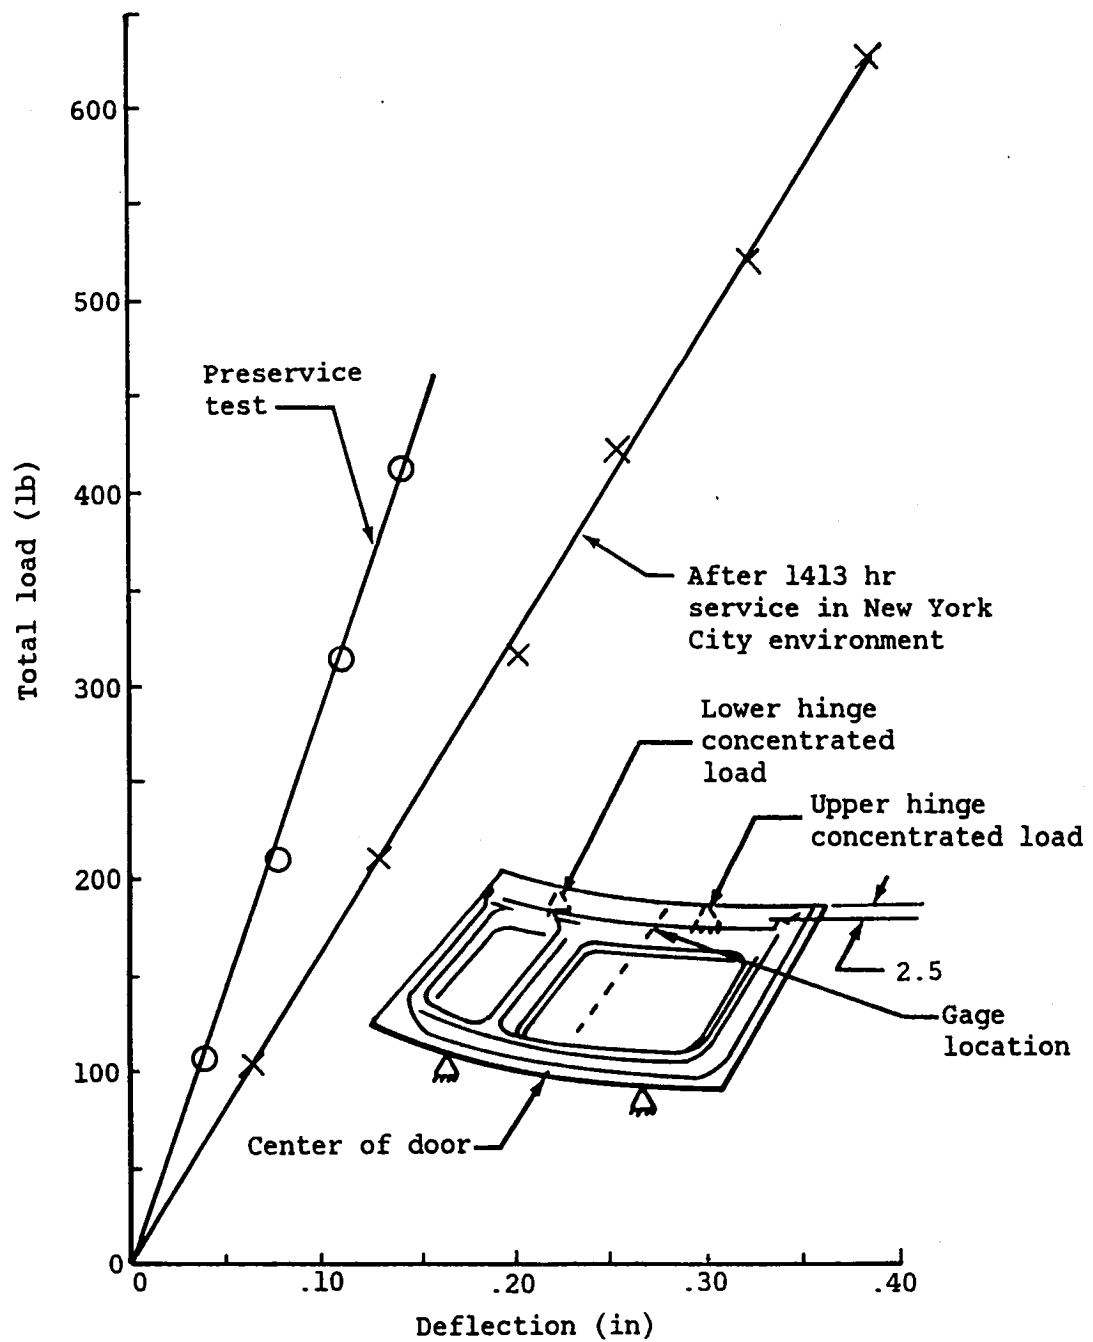
Figure 5. Load-deflection comparison of litter door before service and after 1413 hours of flight in New York City area.

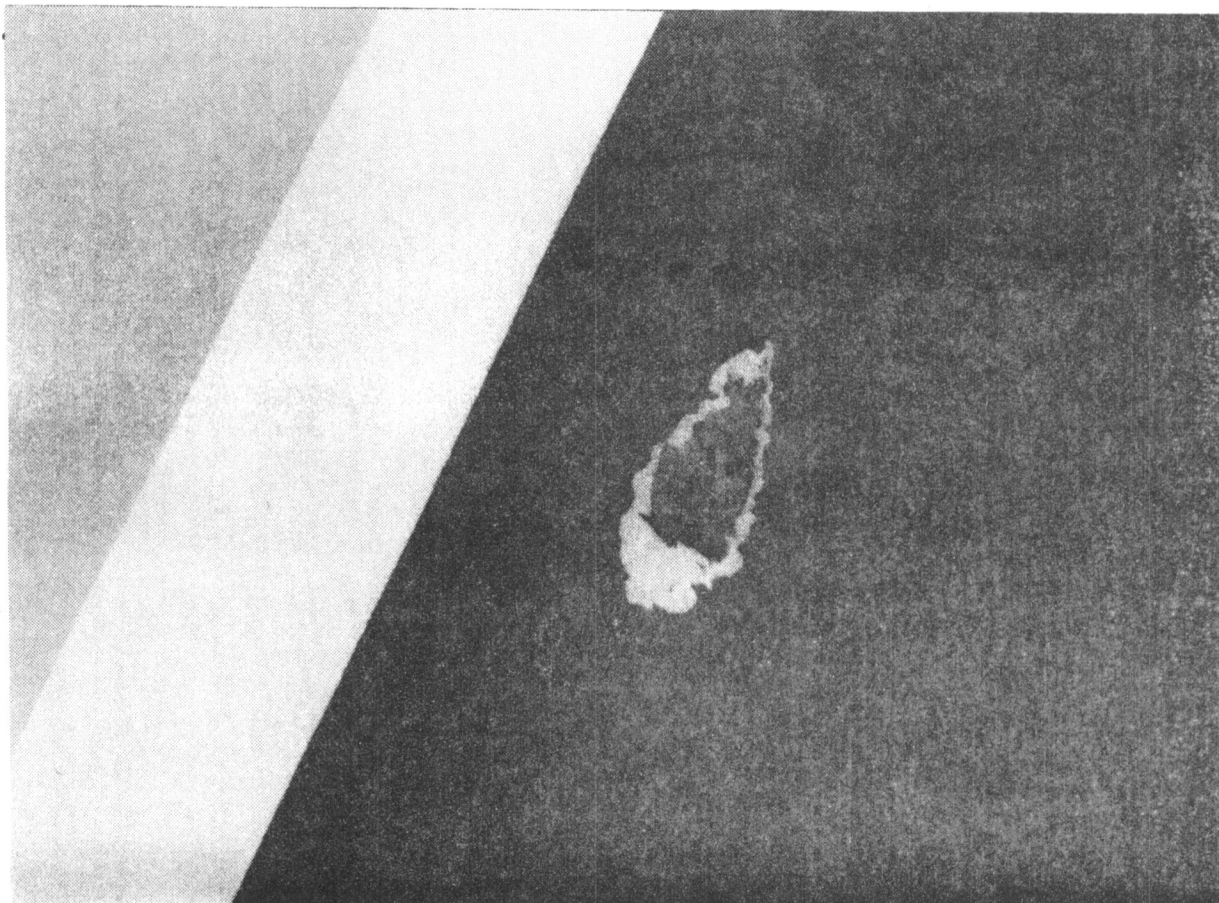
The vertical fin structure was pierced when a helicopter was blown into a sharp object during a windstorm. The accident occurred on an oil rig in the Gulf of Mexico. Figure 6 shows that the damage was about 3 inches in diameter and extended into the honeycomb core, but not to the opposite skin.

Figure 6. Damage to graphite/epoxy vertical fin when pierced by a sharp object.

The repair was made by first cleaning the hole and replacing the fibertruss core with fiberglass honeycomb core. The skins were trimmed down to the core, and a buildup of 6Al-4V titanium sheet was used to make the typical honeycomb sandwich repair. All of the bonding was done with room temperature setting EA 934³ adhesive. Figure 7 shows the repair prior to cleanup and painting. This repair was made at Petroleum Helicopters Inc. who have the equipment to treat titanium at their facility, so it was not necessary to treat it at Bell.

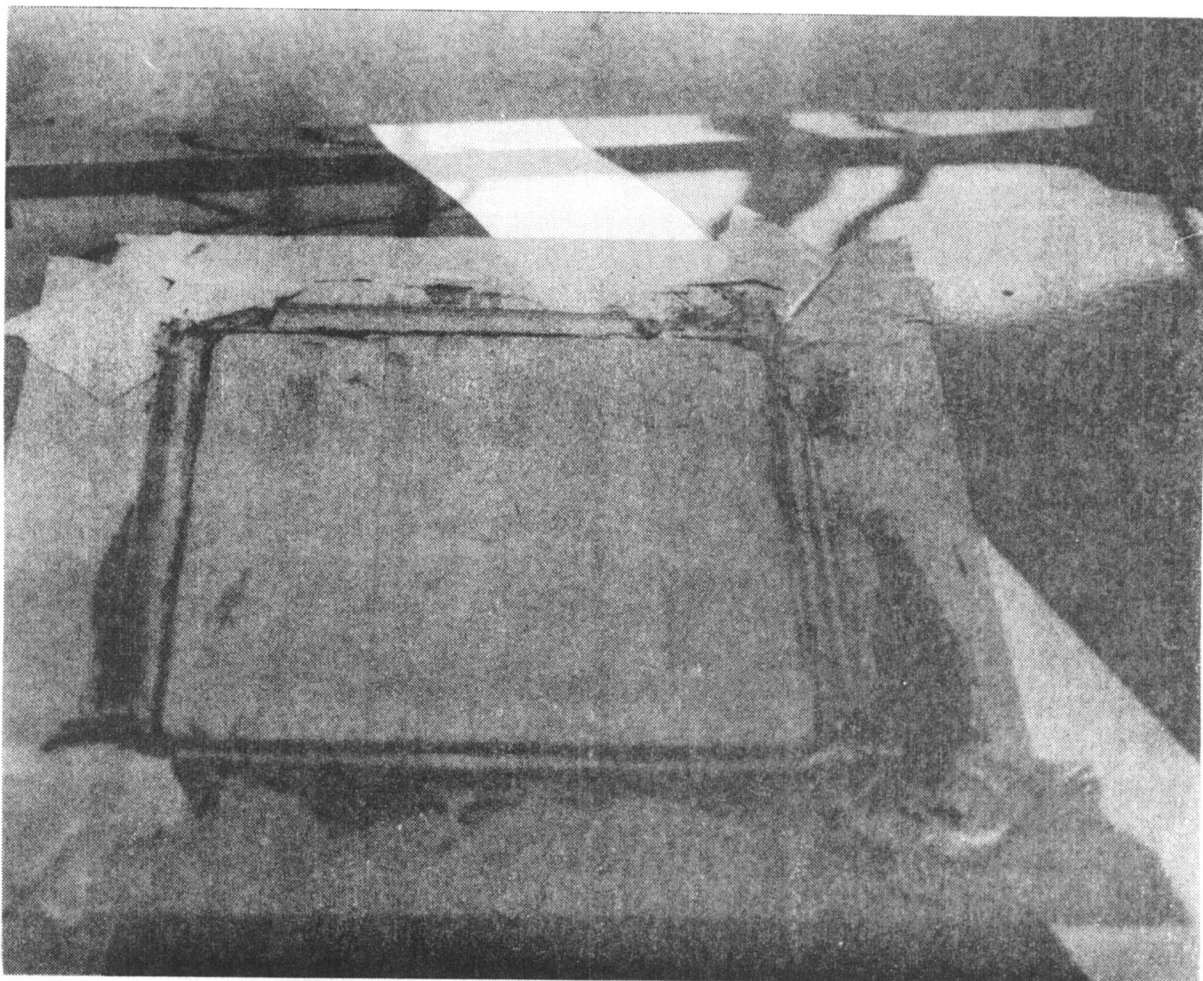
Figure 7. Repair to damaged vertical fin showing titanium repair plate prior to cleanup and painting.

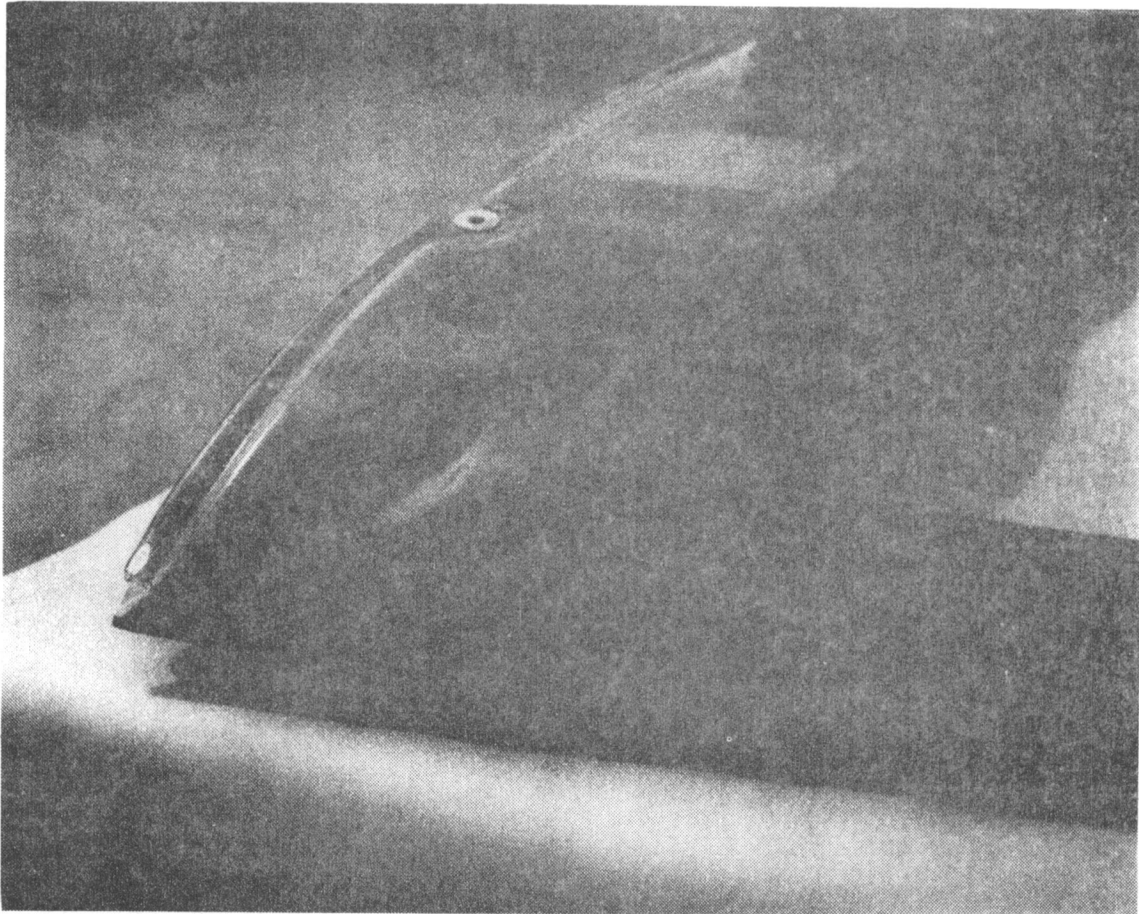
Thermal buckling occurred in the outer skins of the litter doors of four helicopters parked in the Arizona desert during the summer. For all intents and purposes, these helicopters were not flown for the entire summer. Personnel at this facility said they have taken surface temperature measurements on aluminum helicopter structures with the same external paint scheme as the composite, and it is not unusual for the temperatures to reach 200° to 225°F during the summer. The coefficient of thermal expansion of the plexiglass window that is bonded to the Kevlar door structure is 4.5×10^{-5} in/in/°F (which is about 3.5 times that of aluminum alloy), and that of Kevlar/epoxy is 0, so the loads caused by the relative thermal expansion were large enough to cause the thermal buckle shown in Figure 8. This is also evident by the fact

that the bond between the door structure and the window was broken on the four doors, and the disbonds were in the corner near the buckle.

Figure 8. Thermal buckling of composite litter door after exposure to desert heat.

The four doors were returned to Bell for rework. They were clamped in the jig shown in Figure 9 and heated to 220°F for 4 minutes to eliminate the buckle. To preclude a reoccurrence of this type of failure, a rubber seal (Figure 10) was bonded between the door structure and the window to permit relative thermal expansion between the two. This design was tested to ultimate pressure before releasing it for service.

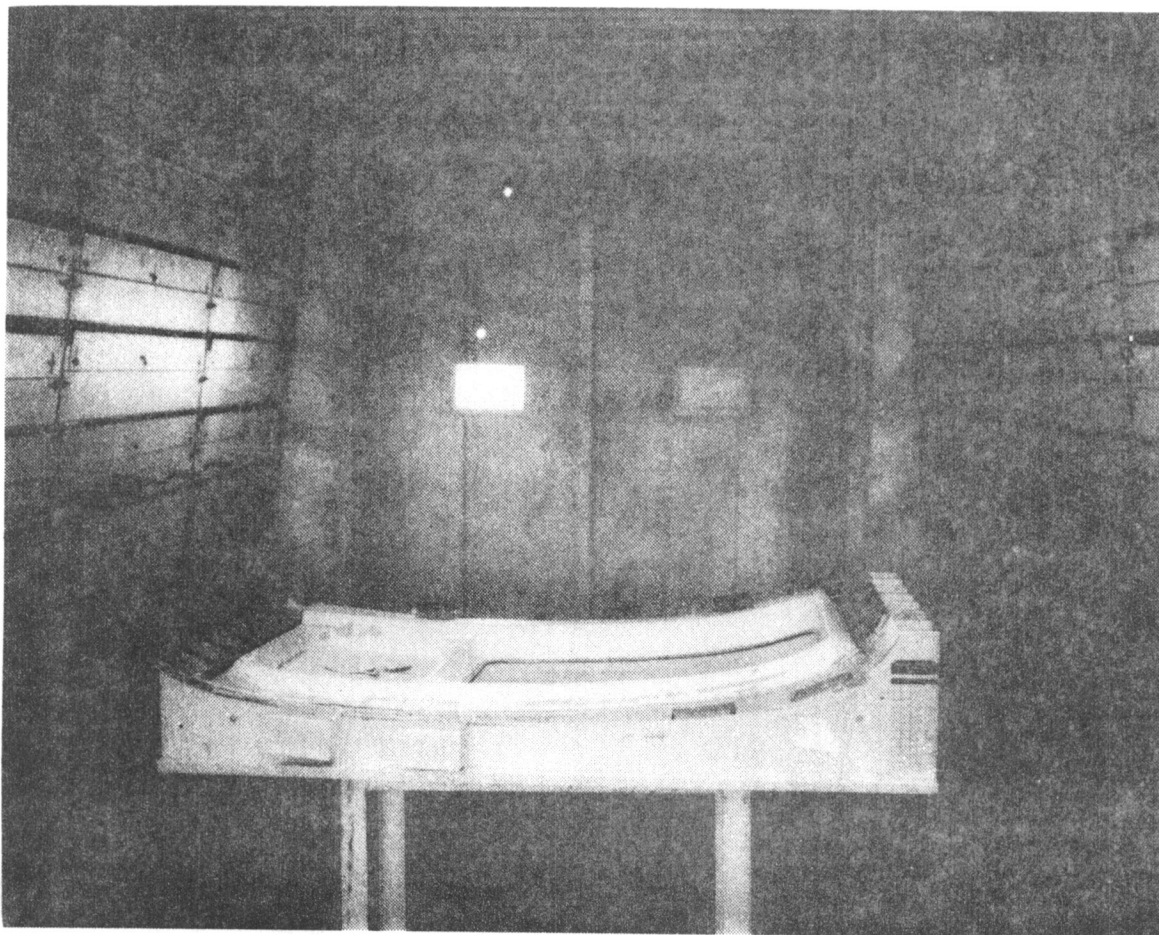
Figure 9. Buckled litter door in straightening jig.

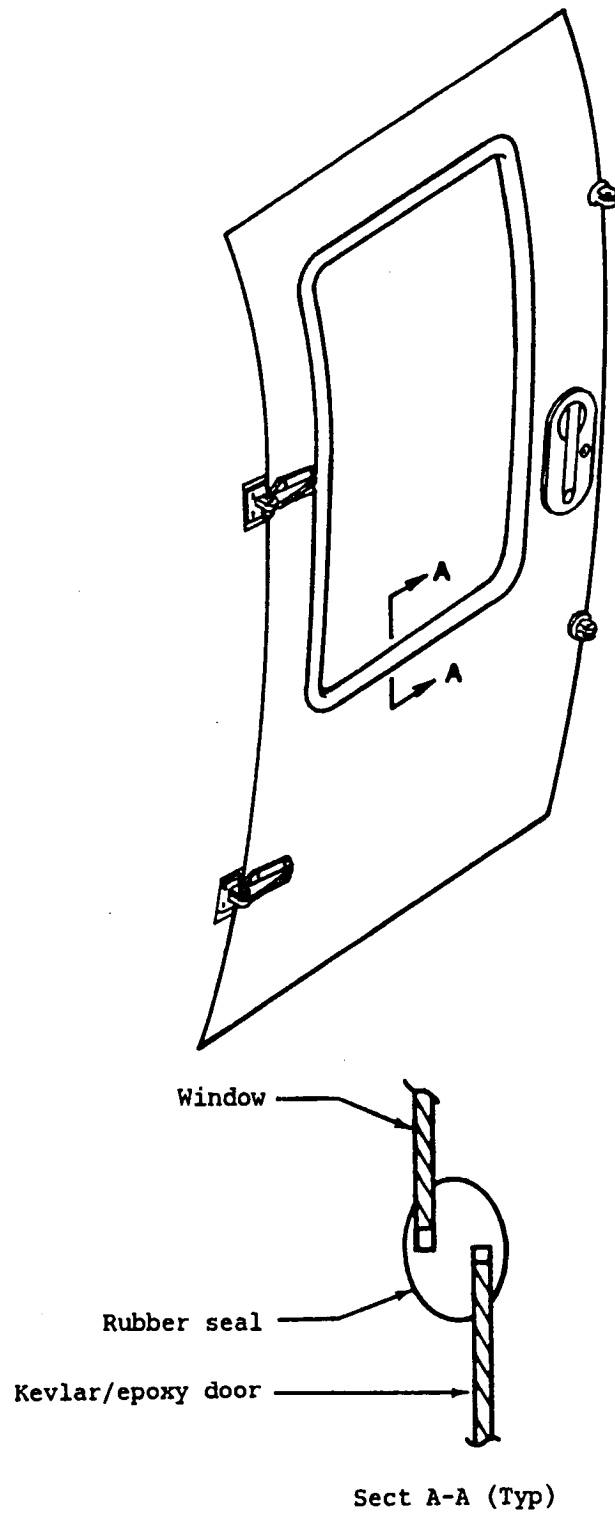
Figure 10. Installation of rubber seal to permit relative motion between window and door structure.

4. The only significant failures in the field occurred on the litter doors, and were in the form of skin buckles, which were caused by differential thermal expansion between the Kevlar/epoxy skin and the plexiglass window. The skin was repaired, and the deficiency was eliminated by inserting a rubber seal between the skin and the window to absorb the relative thermal motion.

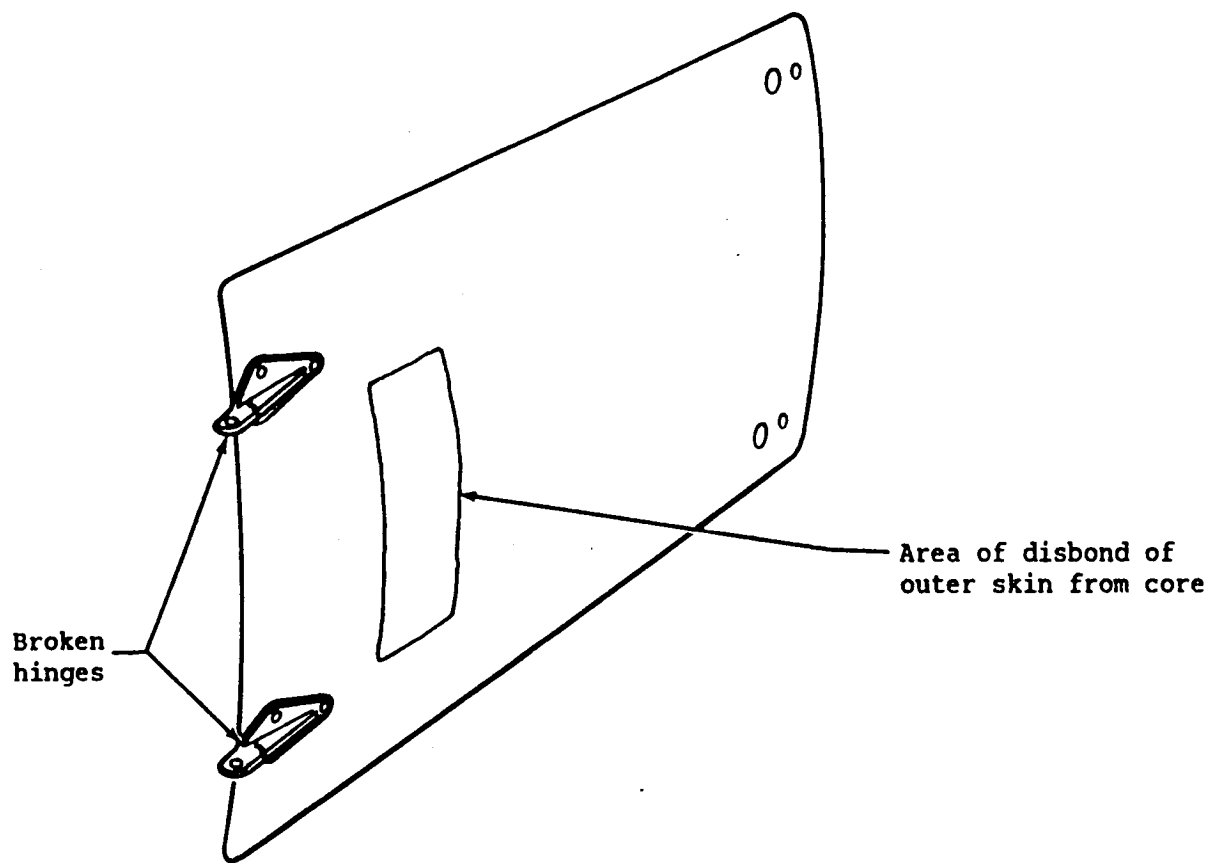
The Canadian Ministry of Transport reported an incident that occurred in the hangar while the helicopter was undergoing routine maintenance. A pressure vessel that is used to inflate the helicopter's floats exploded. A mechanic involuntarily jumped back, hit the inside of the open baggage door, causing it to rotate beyond its normal open position. This caused the door's outer skin

to impact the fuselage skin, and break the hinges. An inspection of the composite revealed the disbonded area shown in Figure 11. The bond of the core to the inner skin remained intact, and there was no evidence of damage to the fuselage structure where the door contacted it. A standard repair was made using a fiberglass wet layup, and the hinges were replaced.

Figure 11. Failure of baggage door at Canadian Ministry of Transport resulting from a ground handling mishap.
